## Failure of a Battery Isolator Switch

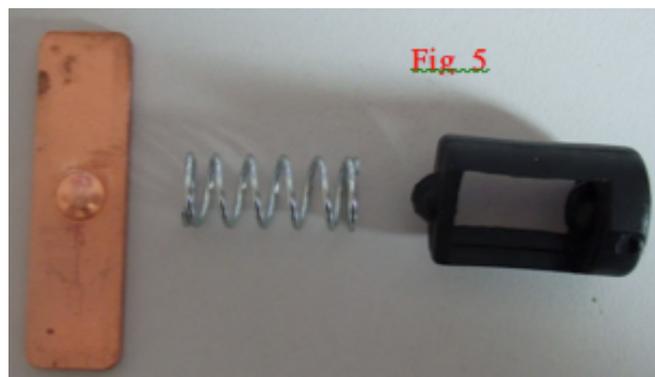
**Update** However on further strip down it appears that there is not a hole in the moving contact see Fig 5 right but a indentation that is designed to locate the spring. The indentation

on the moving contact appears to be central but is smaller than the internal diameter of the spring. It would thus appear that over time the spring has pushed the contact over to one side and caused the off setting of the contact. This may well better explain why the switch appears fine for the first year or so as the side force of the coil spring gradually moves the contact over. Coil springs do have a certain amount of side force when compressed and this in conjunction with the high usage level explain why the switch is OK for a year or so.

Perhaps removing say 1mm from each side of the contact may reduce the amount of the contact moving and prevent it snagging on the case.

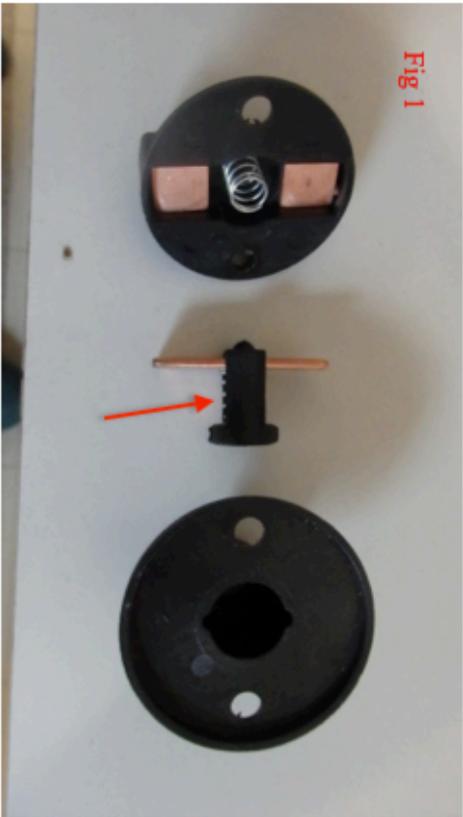
(2) There are two springs and the spring visible in Figs 1,2, and 4 is of lower strength than the spring partly hidden in Fig1, shown by the red arrow. The lower strength spring clearly helps the contacts to part when the switch is turned off and the partly hidden stronger spring in Fig 1 forces the contacts together when the switch is operated to close.

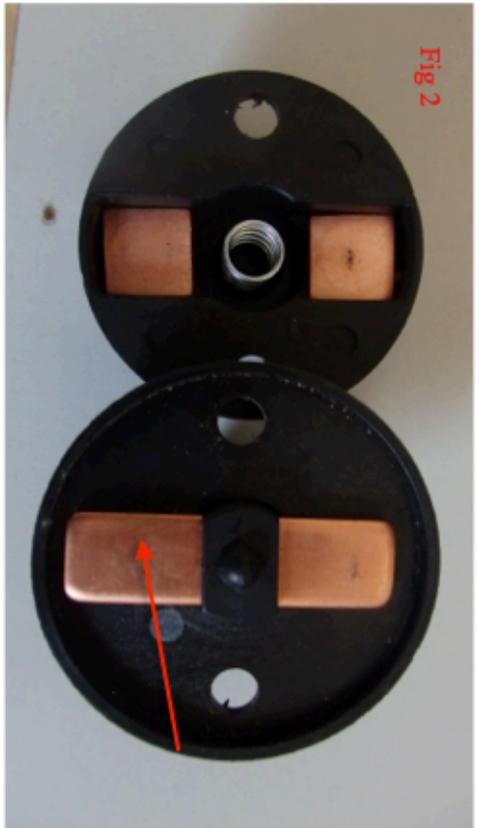
(1) The contacts as shown in the figures are not in any way corroded – in fact they look a bit too clean to be a moderate to high current switch ! Fig 2 shows evidence of contact touching on the upper contacts. Signs of good contact are not readily visible.

(4) Fig 2 shows what may have been the problem. The upper contact is not central, arrow points towards the longer side. Fig 4 the arrow points to the small moulded pin that holds the moving contact, through a small hole in the contact, in its fixed position. Clearly the moving contact while not being central is so close to the lower edge of the case that it may well snag and jam thus preventing closure. My feeling is this may be the problem.

The two visible leafs of the lower contact are 20mm and 17mm so a 1.5mm off centre for the locating of the moving contact is quite a big error.

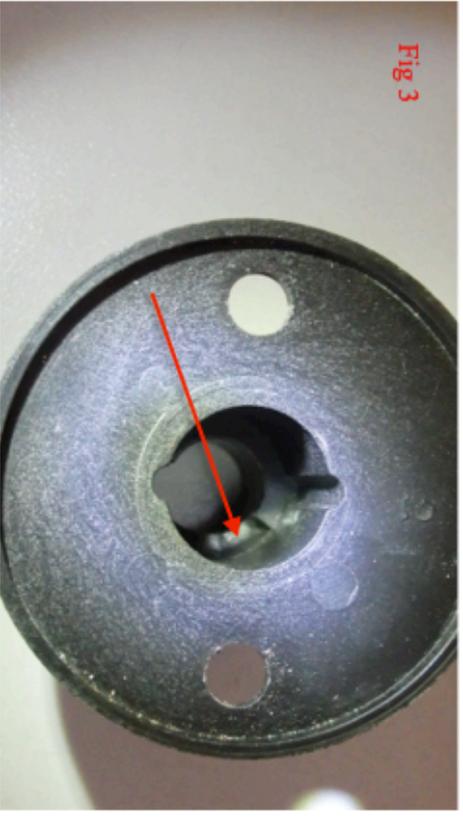
(3) Fig 3 shows that the locking peg for the key, marked by an arrow, has noticeably worn the groove that the key locks into to keep the switch closed.
